Manhole Inspection Summary

Manhole # S17II1012MH

Insp Date: **10/3/08 12:24 PM**

Location Address: **4210 Clarkdale Rd**

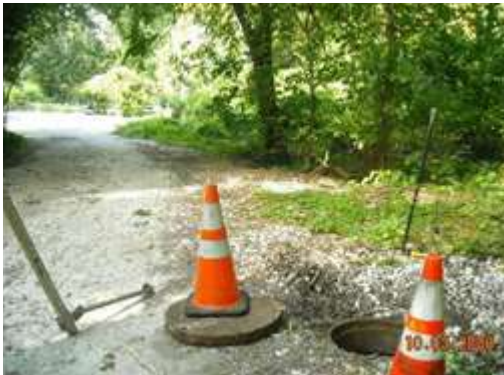
Location View

Comments **ORIGINAL INSPECTION BY RK&K CREW: CH, HDP 01/11/2007. COMPLETED BY REI/DRAYCO. LOCATED JUST OFF THE ROAD UNDER A PILE OF #2 STONE**

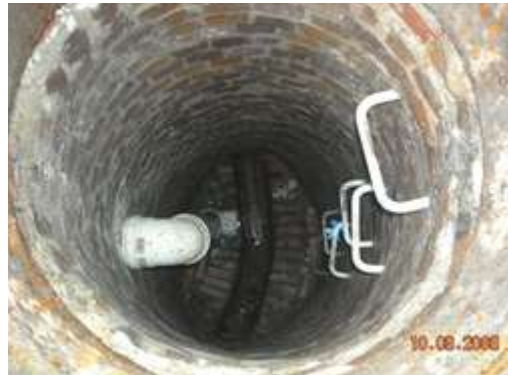
Top View

Condition: ☐ Sound ☐ Cracked ☐ Root Intrusion ☐ Loose Brick ☒ **Deteriorated**

Infiltration: ☐ None ☒ **Joint** ☐ Cracks ☒ **Mortar** ☐ Roots ☐ Wall

Infiltration: ☐ None ☐ Joint ☐ Cracks ☒ **Mortar** ☐ Roots ☒ **Wall**

Adjustment deterioration and infiltration.
Barrel infiltration. Bench debris.

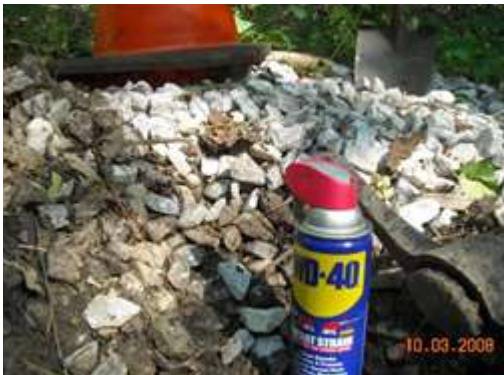
Defect

Below grade - Buried.

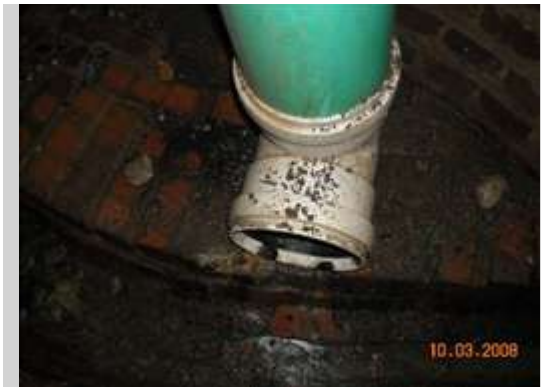
Drop In @ 9 O'Clock

Drop Condition: **Open**
